Road Safety Audit

US 129 / SR 15 ALT / JEFFERSON ROAD
FROM LAVENDER ROAD TO SOUTH HOMEWOOD DRIVE
ATHENS-CLARKE COUNTY | GEORGIA

Prepared for the Georgia Department of Transportation

December 2016

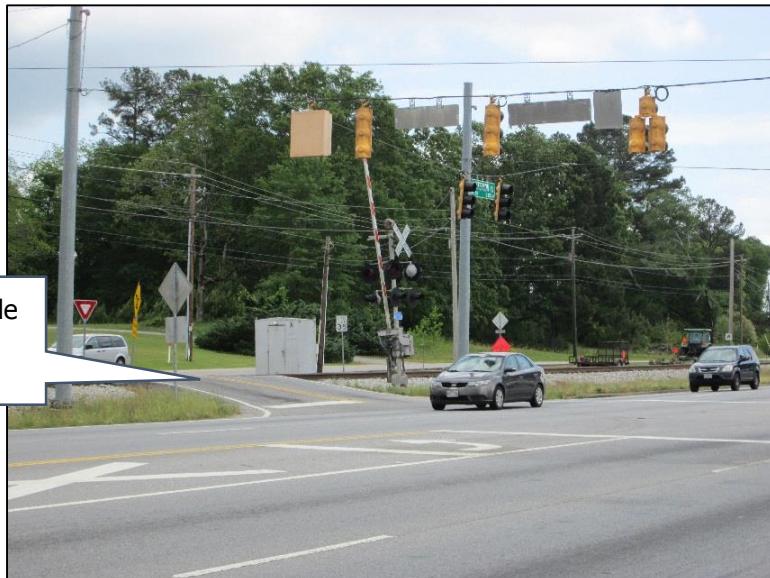
FIGURE 11. SHORT TURN LANES AND INSUFFICIENT STORAGE AT INTERSECTIONS THAT CROSS RAILROAD TRACKS, SEEN HERE AT WHITEHEAD ROAD.

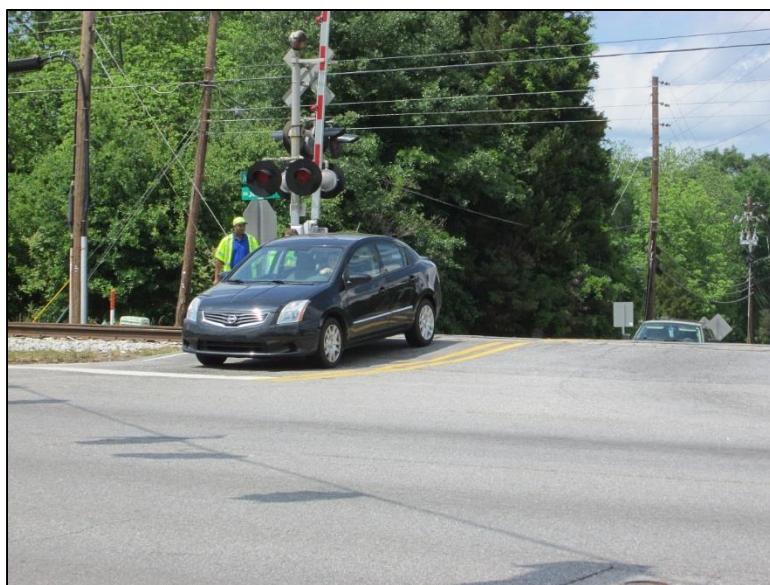
FIGURE 12. SINGLE VEHICLE FILLS STORAGE AREA BEHIND STOP BAR ON JEFFERSON RIVER ROAD.

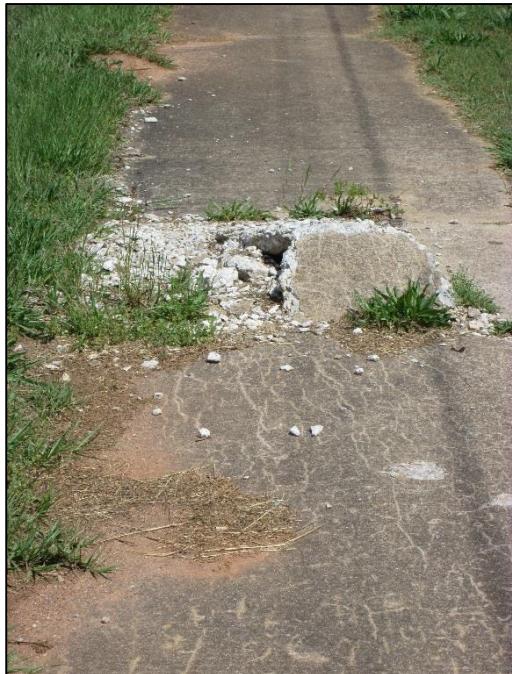
4. There are sidewalks along the west side of the corridor, but many segments are **cracked or damaged**, and in some areas the sidewalk is **narrow** and **close to the travel lanes**.

FIGURE 14. DAMAGED SIDEWALK ALONG THE CORRIDOR.

SAFETY BENEFIT	LEVEL OF EFFORT	TIME FRAME	COST
1. Repair and/or install ADA-compliant sidewalks as needed along the west side of the study corridor to provide consistent, predictable pedestrian access and safety.	High	Moderate	Intermediate	Moderate
2. Install ADA-compliant pedestrian facilities at intersections, including curb ramps, truncated domes, and pedestrian push button signals.	High	Moderate	Short Term	Moderate
3. Install crosswalks across all side streets where sidewalk is present to alert motorists to the potential presence of pedestrians.	High	Low	Short Term	Low
4. Replace pavement markings and raised pavement markers (RPMs) throughout the study corridor.	High	Low	Short Term	Low
5. Install reflective backplates on traffic signals along the corridor to improve visibility of signals.	Moderate	Low	Short Term	Moderate

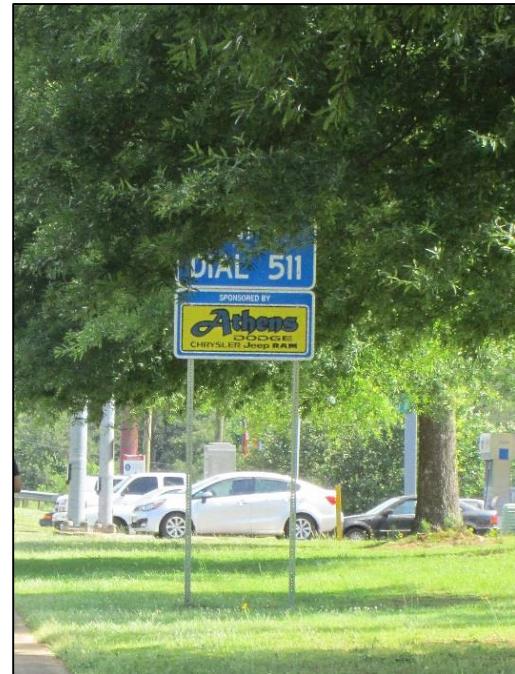
9. **Double-headed arrow signs** (to indicate drivers must turn left or right) **are missing** at T-intersections along the study corridor.
10. **Vegetation** was found to **block some signs** and **commercial driveways** throughout the corridor.

FIGURE 13. SIGN BLOCKED BY VEGETATION.

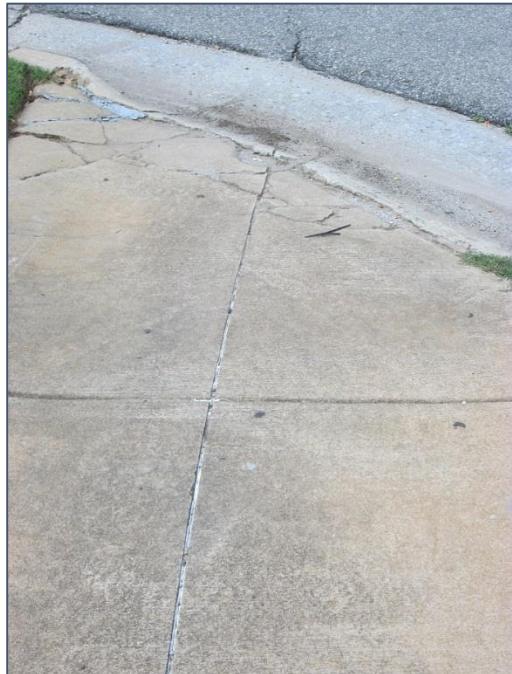
FIGURE 15. MISSING TRUNCATED DOMES ON PEDESTRIAN RAMPS

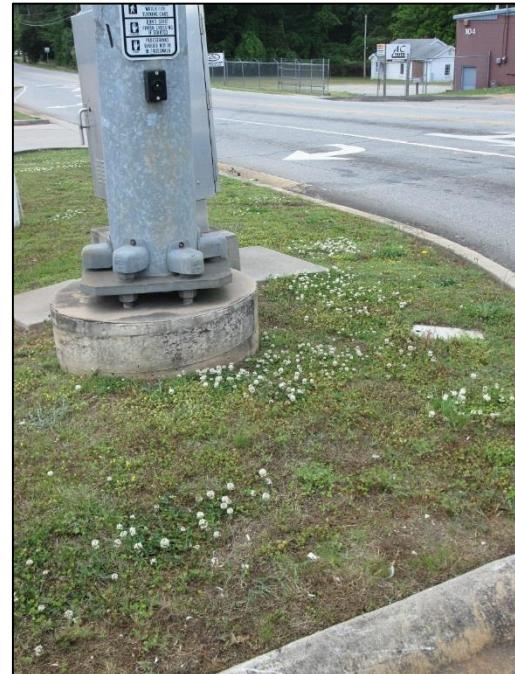
FIGURE 16. OUTDATED PEDESTRIAN SIGNAL PUSH BUTTON WITH NO PEDESTRIAN RAMP OR SIDEWALK.

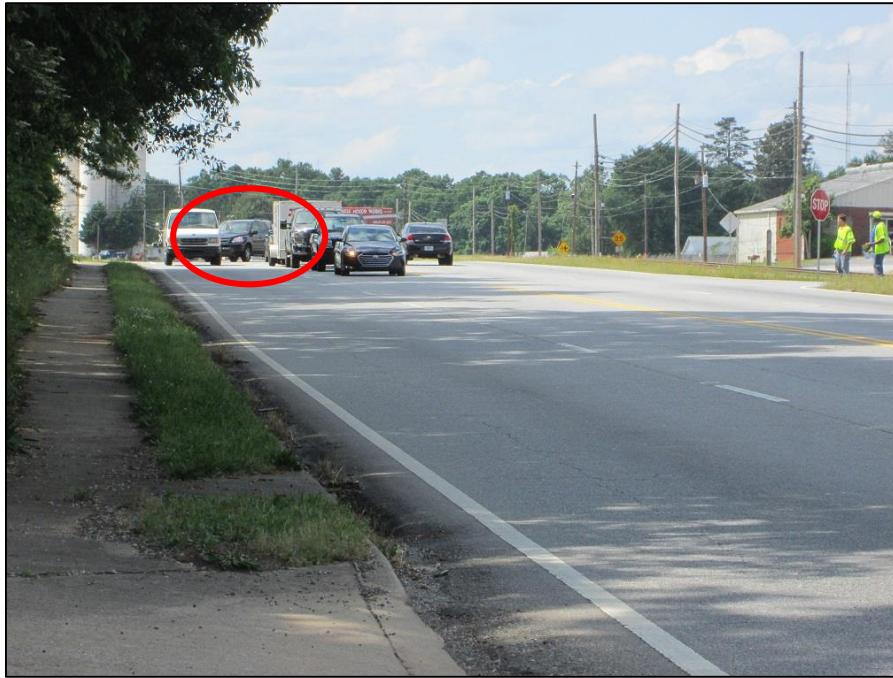
FIGURE 17. TYPICAL SCENE IN WHICH VEHICLES PULL INTO ADJACENT LANES TO GET AROUND THOSE WAITING TO TURN LEFT ONTO A SIDE STREET, SEEN HERE AT THE ENTRANCE TO THE KINDER MORGAN FACILITY.

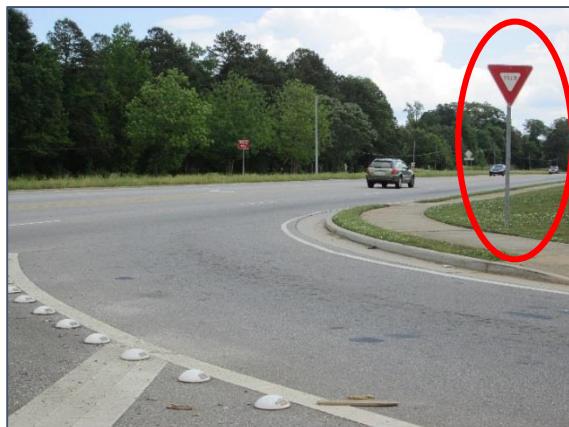
FIGURE 22. YIELD SIGN AT INCORRECT ANGLE IN THE SOUTHWEST CORNER OF THE INTERSECTION.

SAFETY BENEFIT	LEVEL OF EFFORT	TIME FRAME	COST
1. Remove or reposition the "Do Not Enter" sign on the east side of the intersection.	Moderate	Low	Short Term	Low
2. Adjust the angle of the yield sign in the southwest quadrant to make it more visible to motorists turning right from Lavender Road onto the study corridor.	Moderate	Low	Short Term	Low
3. Replace the street sign for Lavender Road with a reflective street sign.	High	Low	Short Term	Low
4. Consider replacing the painted island with a concrete one to channelize turns and improve visibility of the side street.	Moderate	Moderate	Intermediate	Moderate
5. Consider redesigning the intersection to remove the skew angle. Identify and carry out implementation steps as appropriate.	High	High	Long Term	High

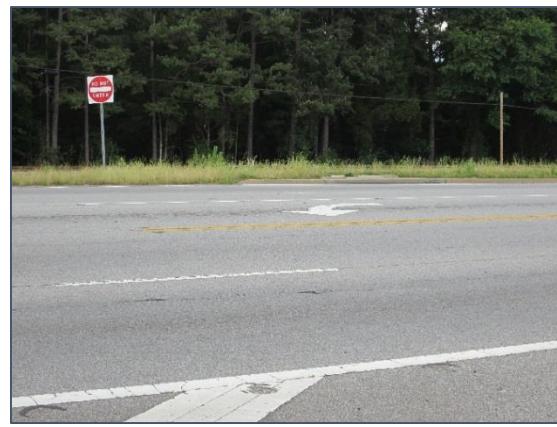
FIGURE 21. MISLEADING "DO NOT ENTER" SIGN FACING SOUTHBOUND DRIVERS NEAR LAVENDER ROAD.

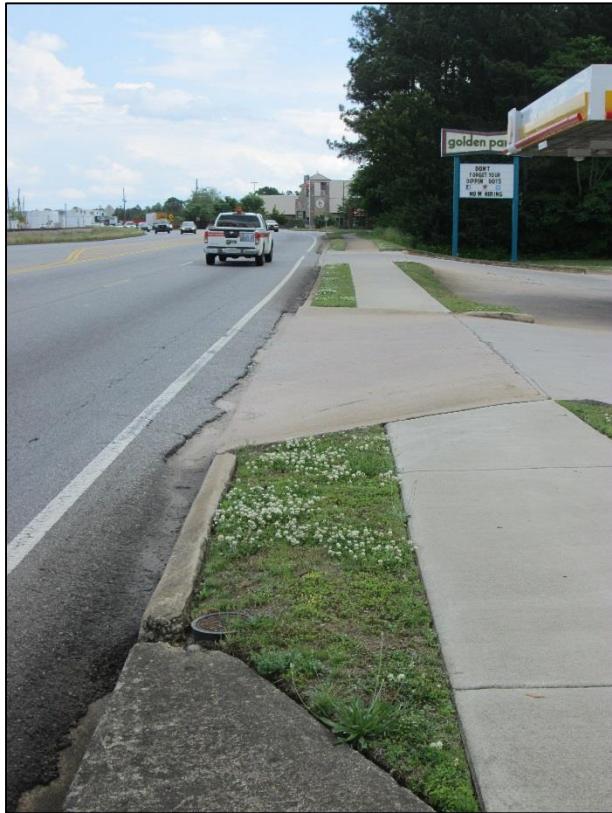
4. On Whitehead Road, the **driveway** for the former automobile repair shop is **too close to the intersection**.

FIGURE 25. DRIVEWAY TOO CLOSE TO INTERSECTION AND NO LEFT-TURN LANE INTO GAS STATION.

4. Convert the northernmost driveway at the Shell gas station to right-in/right-out.	High	Low	Short Term	Low
5. Consider reconfiguring the driveway to the former automobile repair shop (northwest quadrant), so that turning movements at the business do not interfere with traffic flow. This could be done by closing off or tapering part of the driveway to force people to exit farther from the intersection.	Moderate	Moderate	Intermediate	Moderate

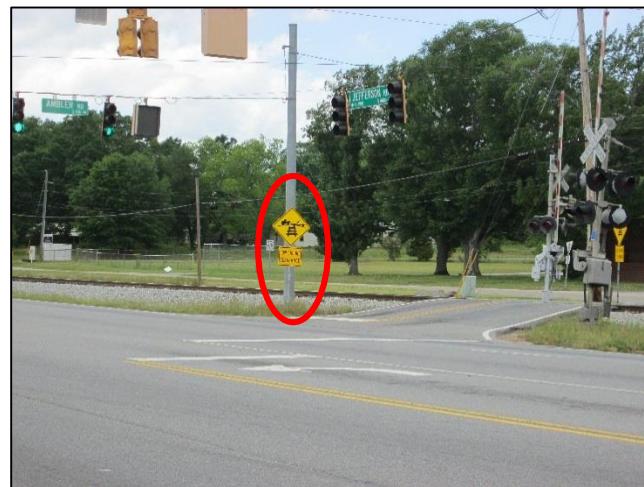
FIGURE 26. LOW GROUND CLEARANCE SIGN ON FAR SIDE OF INTERSECTION SHOULD BE RELOCATED TO NEAR SIDE.

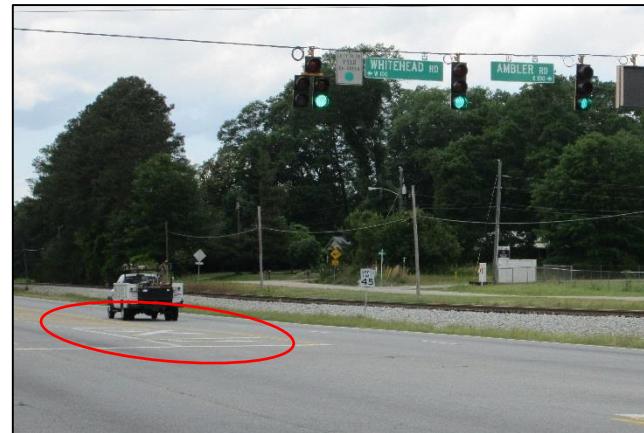
FIGURE 27. SHORT TURN LANES AND INSUFFICIENT LANE STORAGE FOR VEHICLES TURNING ONTO WHITEHEAD ROAD.

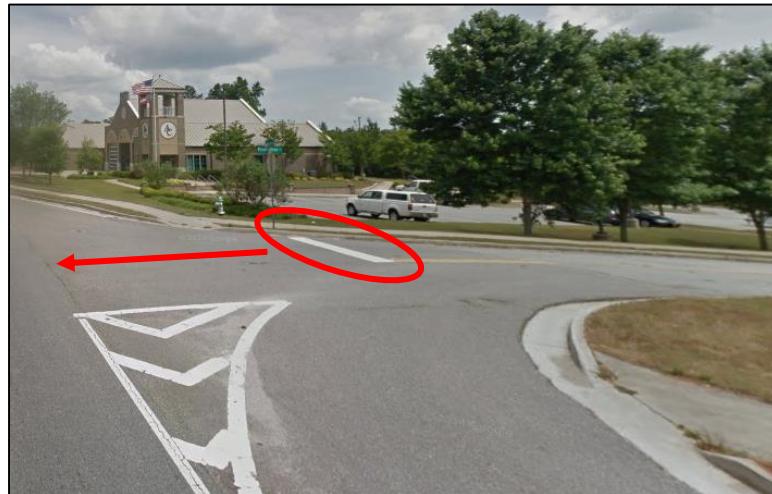
1. The **stop bar** on the west leg of the intersection, across Firefighter Court, is **set too far back**, creating **sight distance issues** for vehicles turning onto US 129/SR 15 Alt/Jefferson Road.
2. The **"Do Not Enter" sign** at the fire station is **incorrectly angled** towards US 129/SR 15 Alt/Jefferson Road and may be misleading to approaching motorists.

FIGURE 30. STOP BAR SET TOO FAR BACK ON FIREFIGHTER COURT.

SAFETY BENEFIT	LEVEL OF EFFORT	TIME FRAME	COST
1. Relocate the stop bar across Firefighter Court closer to the intersection.	High	Low	Short Term	Low
2. Adjust the angle of the "Do Not Enter" sign to face the proper direction.	Moderate	Low	Short Term	Low

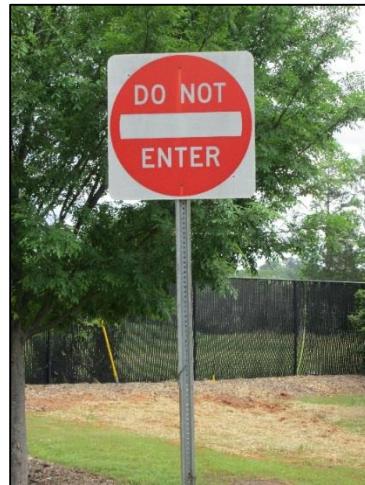
FIGURE 32. "DO NOT ENTER" SIGN AT FIRE STATION DRIVEWAY FACES TOWARD STUDY CORRIDOR.

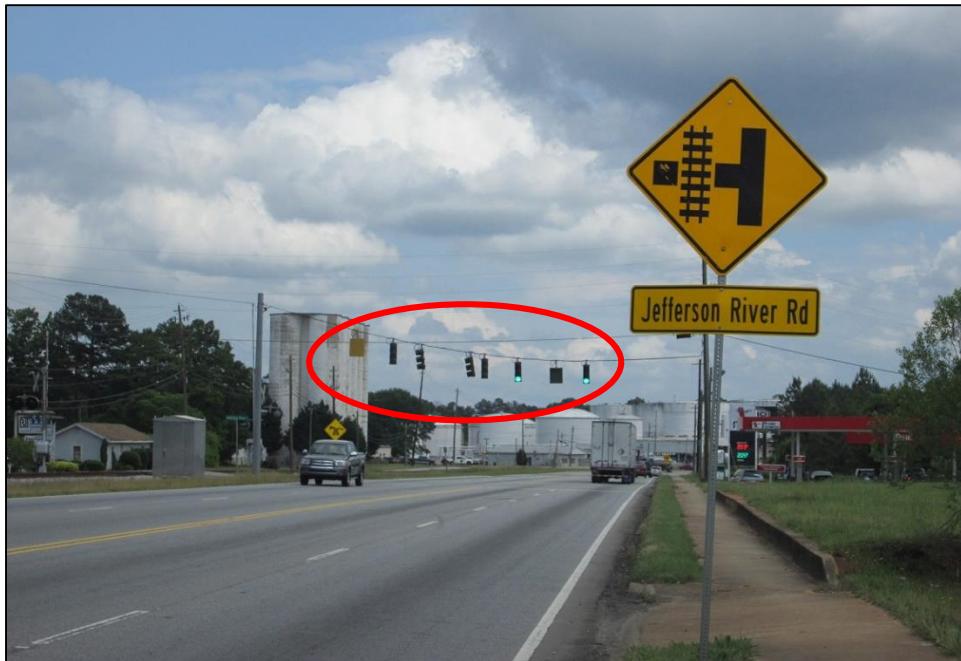
FIGURE 34. JEFFERSON RIVER ROAD INTERSECTION, VIEWED FROM SOUTHBOUND LANES. NOTE ALL TRAFFIC SIGNALS ARE ON SAME OVERHEAD LINE.

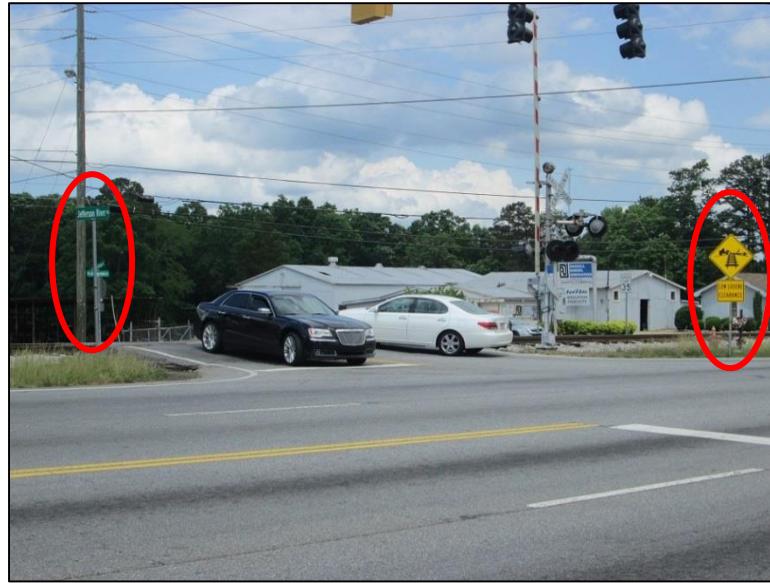
FIGURE 35. RAILROAD CROSSING AT JEFFERSON RIVER ROAD. NOTE "LOW GROUND CLEARANCE" SIGN ON FAR SIDE OF INTERSECTION AND SMALL POST-MOUNTED STREET NAME SIGN.

SAFETY BENEFIT	LEVEL OF EFFORT	TIME FRAME	COST
1. Relocate the "Low Ground Clearance Sign" to the southeast corner of the intersection.	Moderate	Low	Short Term	Low
2. Install an overhead street name sign for Jefferson River Road.	High	Low	Short Term	Low
3. Relocate the blocked signal head to allow the signal to be more visible from Jefferson River Road.	High	Low	Short Term	Low
4. Consider re-installing the traffic signals on mast arms or separate overhead wires to reduce visual clutter and improve visibility of the signals.	High	Moderate	Intermediate	Moderate
5. Install a street light at the intersection.	High	Moderate	Intermediate	Moderate
6. Consider realigning the driveway for the gas station to tie into the signalized intersection or converting the northernmost driveway to right-in/right-out.	High	Moderate	Intermediate	Moderate

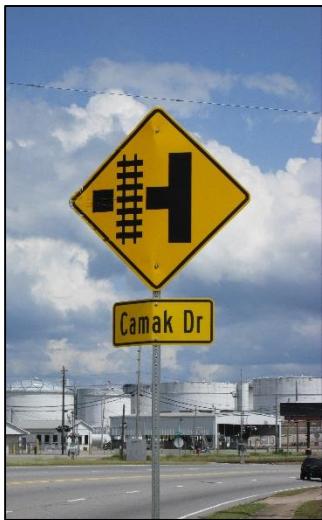
FIGURE 38. DAMAGED INTERSECTION AHEAD AND RAILROAD CROSSING SIGN.

SAFETY BENEFIT	LEVEL OF EFFORT	TIME FRAME	COST
1. Repair or replace the advanced warning sign for the intersection.	Moderate	Low	Short Term	Low
2. Remove the empty sign posts in front of the church near the intersection.	Moderate	Low	Short Term	Low
3. Remove the existing guardrail at the intersection and replace with a guardrail that meets current standards.	High	Moderate	Short Term	Moderate
4. Create a buffer or barrier along the sidewalks at the intersection.	High	Moderate	Intermediate	Moderate
5. Investigate the possibility of closing the intersection or converting the intersection to a right-in/right-out only. Camak Drive connects to Jefferson River Road and motorists could use the signal at that intersection for access to US 129/SR 15 Alt/Jefferson Road.	High	Moderate	Intermediate	Moderate

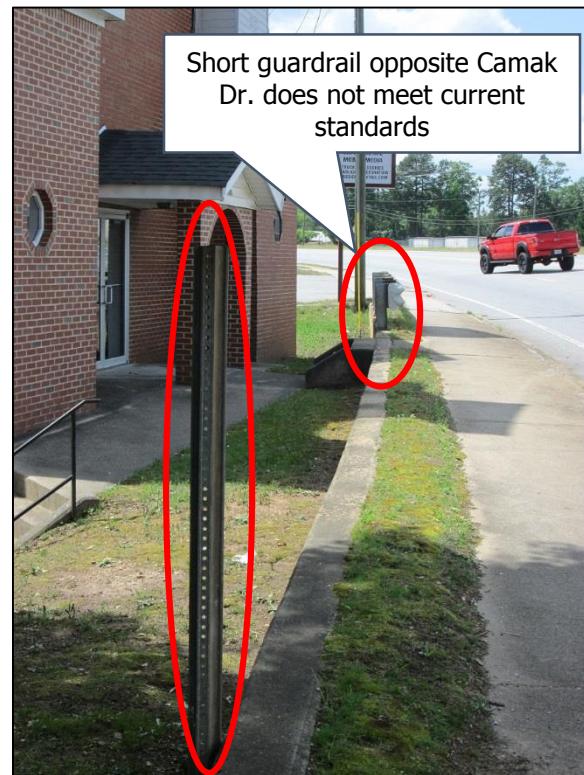
6. There is **no buffer along the sidewalks** on the west side of the study corridor, placing **pedestrians very close to the travel lanes**.
7. There are two **sign posts** at the church (at the southwest corner of the intersection) that are **missing sign faces**.

FIGURE 37. EMPTY SIGN POST, SHORT GUARDRAIL, AND SIDEWALK WITH NO BUFFER NEXT TO TRAVEL LANES IN FRONT OF ST. JAMES BAPTIST CHURCH OPPOSITE OF CAMAK DRIVE.

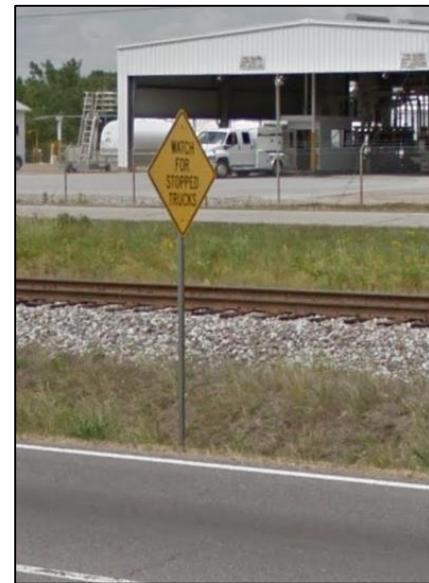
FIGURE 40. FADED, WORN SIGN ADVISING MOTORISTS OF POSSIBLE STOPPED TRUCKS AHEAD.

SAFETY BENEFIT	LEVEL OF EFFORT	TIME FRAME	COST
1. Investigate sight distance issues at the intersection and consider converting Putters Drive to right-in/right-out. Implement if determined to be feasible.	High	Moderate	Intermediate	Moderate
2. Replace the "Watch for Stopped Trucks" sign so that it is more visible and reflective.	Moderate	Low	Short Term	Low

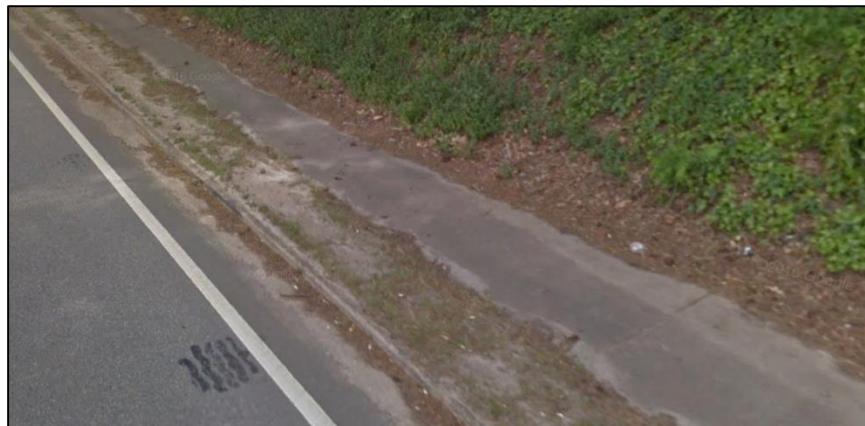
1. There is **no street sign** for Crescent Road.
2. **Debris and sediment** was observed in the roadway, indicating **poor drainage at the intersection**.
3. On US 129/SR 15 Alt/Jefferson Road just north of Crescent Road, there is a **driveway that is too close to the intersection**.

FIGURE 44. DEBRIS AND SEDIMENT ON SIDEWALK NORTH OF CRESCENT ROAD.

SAFETY BENEFIT	LEVEL OF EFFORT	TIME FRAME	COST
1. Install a post-mounted street name sign for Crescent Road at the intersection.	High	Low	Short Term	Low
2. Investigate and repair the drainage issues at the intersection if warranted.	Moderate	High	Intermediate	Moderate
3. Reconfigure or re-locate the driveway to have its access point on Crescent Road rather than on the study corridor.	High	Moderate	Intermediate	Moderate

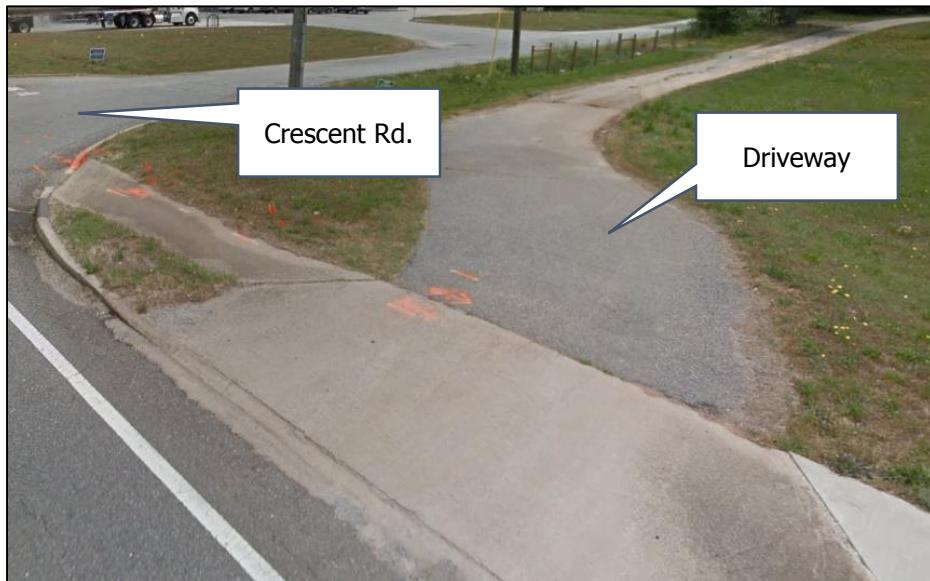
FIGURE 45. DRIVEWAY TOO CLOSE TO INTERSECTION AT CRESCENT ROAD.

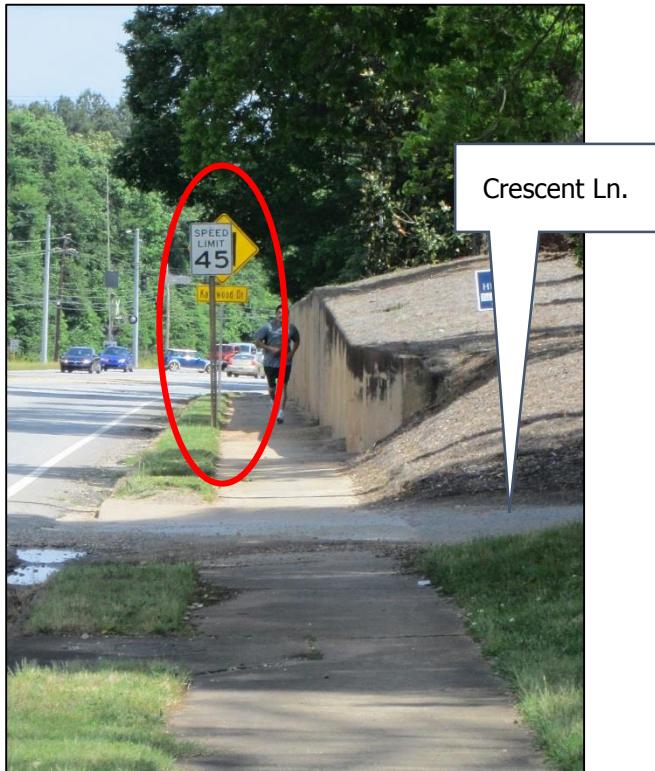
FIGURE 48. VIEW SOUTHBOUND ALONG SIDEWALK ACROSS CRESCENT LANE. NOTE SIGN BLOCKING OTHER SIGN.

SAFETY BENEFIT	LEVEL OF EFFORT	TIME FRAME	COST
1. Clear the sediment from the sidewalk and repair the retaining wall at the intersection.	Moderate	Low	Short Term	Low
2. Relocate speed limit and "Intersection Ahead" signs so they do not block one another.	Moderate	Low	Short Term	Low

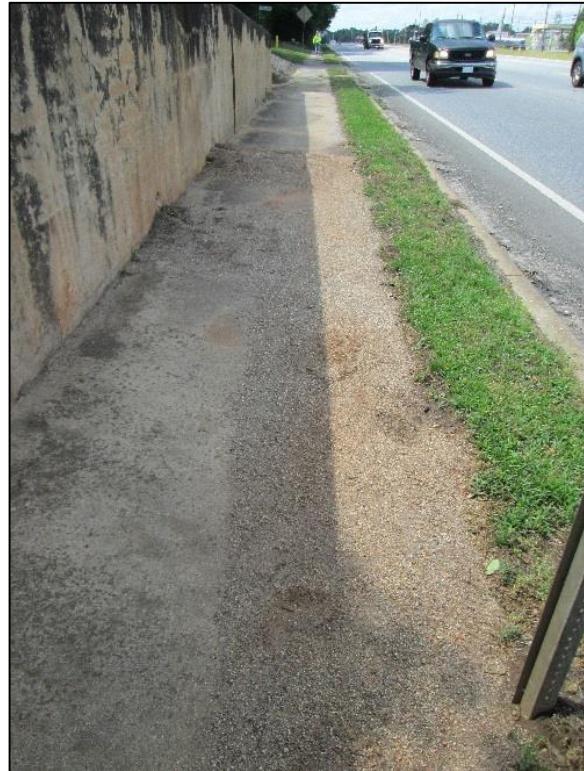
1. Crescent Lane is a **private road**.
2. **Sediment** from the retaining wall at the south of the intersection was observed **on the sidewalk**.
3. Just south of Crescent Lane, a **speed limit sign blocks the "Intersection Ahead" sign** for Kathwood Drive from some angles.

FIGURE 47. CLOSE-UP OF SEDIMENT FROM RETAINING WALL ON THE SIDEWALK.

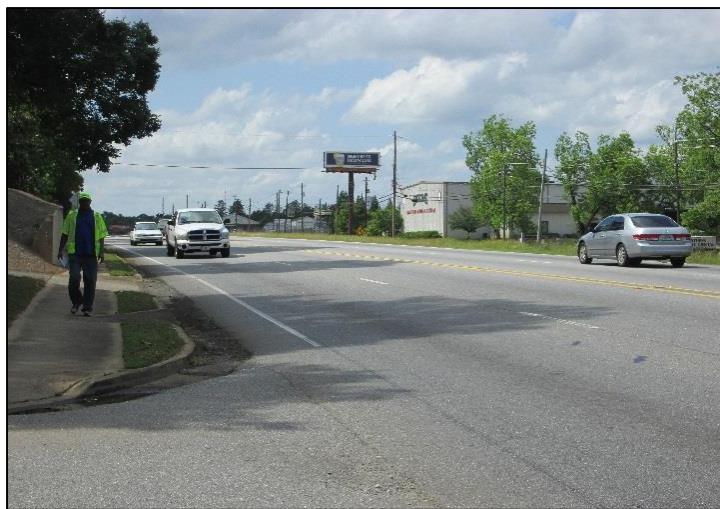
1. There is **no advanced warning sign** for the intersection.
2. There are **sight distance issues** for vehicles turning from Moss Side Drive onto US 129/SR 15 Alt/Jefferson Road. This is due to the **retaining wall** on the northwest corner of the intersection and **overhanging vegetation** on the southwest corner of the intersection.
3. Moss Side Drive **connects with Trinity Place to the south**, providing a signalized intersection that could be used for safer access to northbound US 129/SR 15 Alt/Jefferson Road if needed.

FIGURE 50. LIMITED SIGHT DISTANCE FROM MOSS SIDE DRIVE (LOOKING NORTHBOUND).

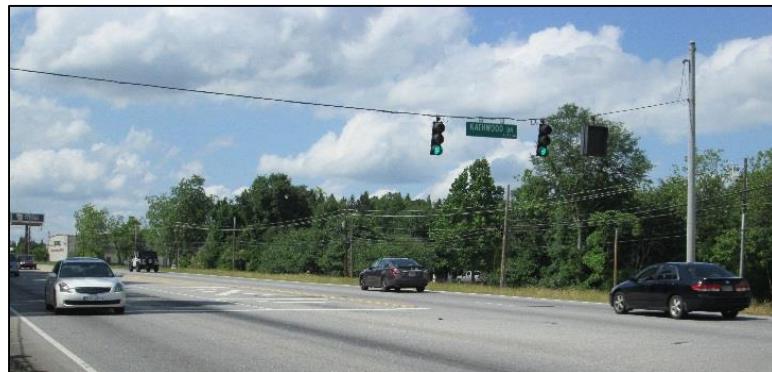
FIGURE 53. LOW-HANGING TRAFFIC SIGNALS AT KATHWOOD DRIVE.

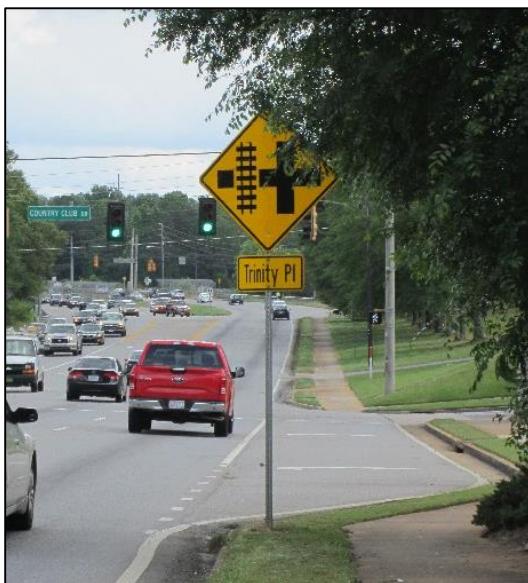
FIGURE 57. SIGN MISSING REFERENCE TO ATHENS COUNTRY CLUB.

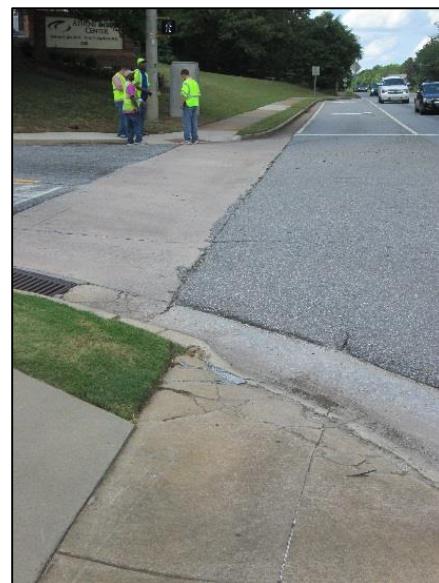
FIGURE 56. SIDEWALKS INCORRECTLY ALIGNED FORCE PEOPLE ON THE SIDEWALK INTO TRAVEL LANES.

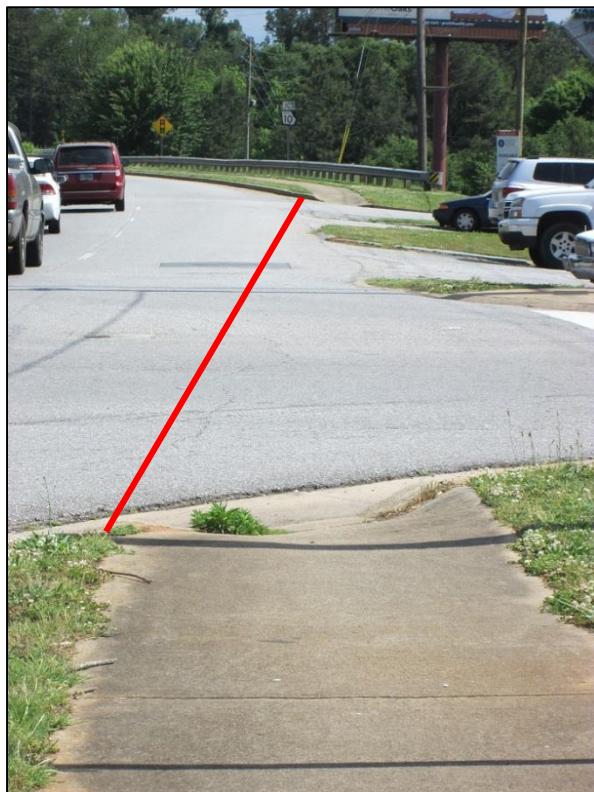
FIGURE 60. SIDEWALKS ACROSS S. HOMWOOD DRIVE DO NOT ALIGN.

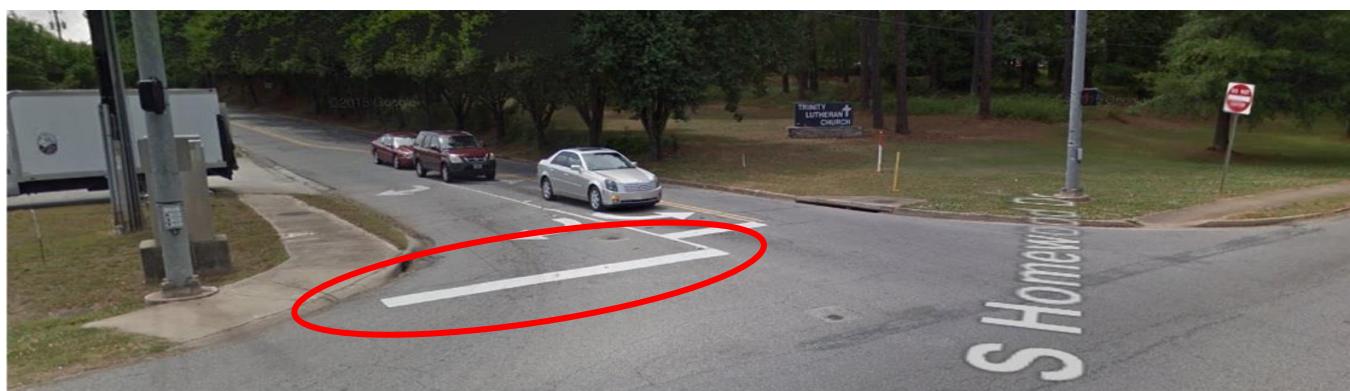
FIGURE 61. PEDESTRIAN RAMPS DO NOT ALIGN AND STOP BAR IS AHEAD OF PEDESTRIAN RAMP ON SOUTHWEST CORNER.
