**CDO for Agenda Item 25 - Relocation of Mill Houses at 110 Puritan Lane and 1060 Macon Highway for Future Affordable Housing Use (Thornton)**

**SUBJECT:** Relocation of Mill Houses at 110 Puritan Lane and 1060 Macon Highway for Future Affordable Housing Use

**DATE:** October 29, 2025

# Asbestos Inspection Report

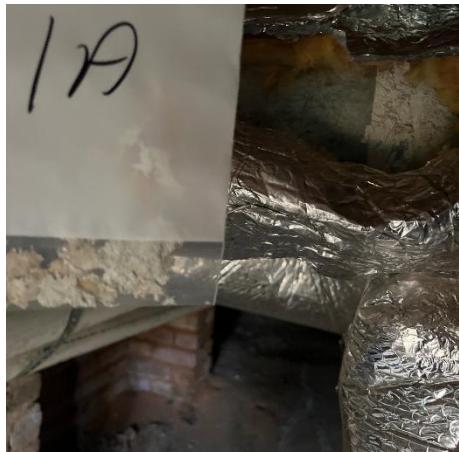
1A, Duct Tape, Crawlspace

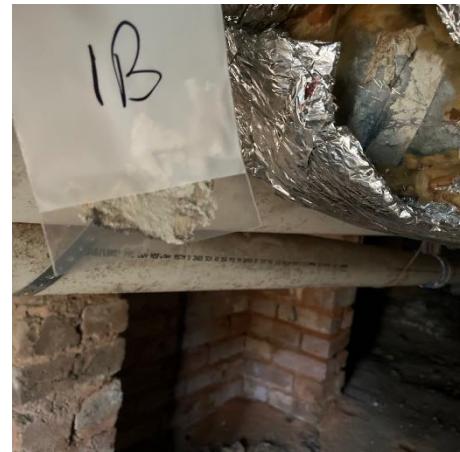
1B, Duct Tape, Crawlspace

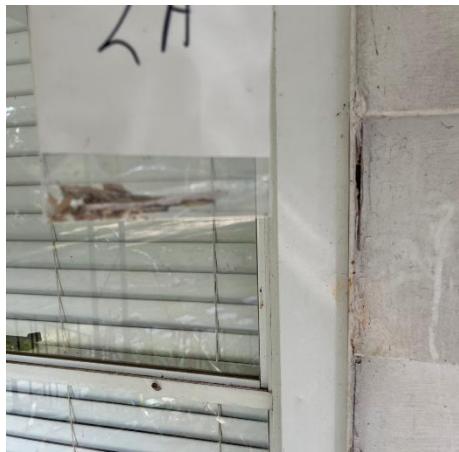
2A, Caulk, Right Front Window

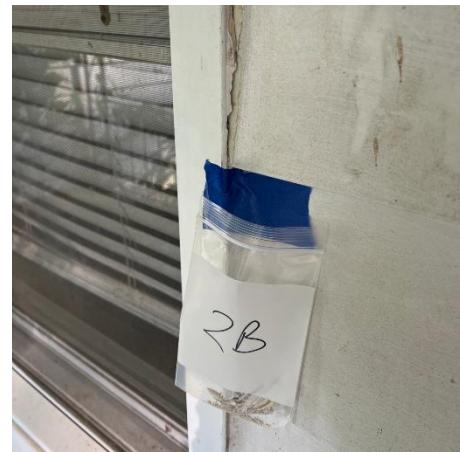
2B, Caulk, Front Porch Window

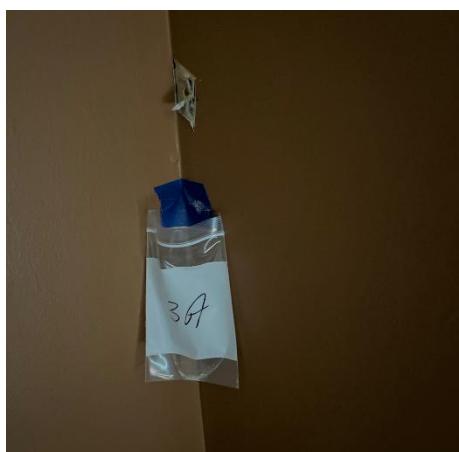
3A, Wall System, Living Room

<b>3A</b> Layer A 3741901	Joint Compound W/ Brown Paint	Homogeneous Gray Non-Fibrous Bound		2% 25% 71%	Mica Paint Binder	<span style="background-color: red; color: white; padding: 2px;">Chrysotile 2%</span>
Layer B 3741901	Tape	Homogeneous Brown Fibrous Loosely Bound	100%	Cellulose		<b>None Detected</b>

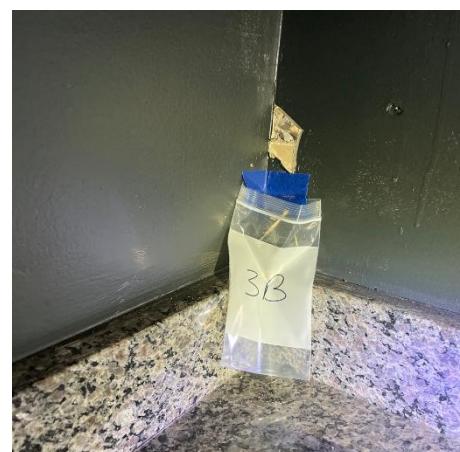
3B, Wall System, Kitchen

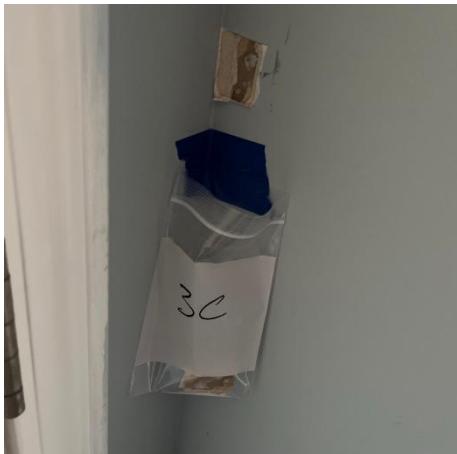
3C, Wall System, Left Middle Bedroom

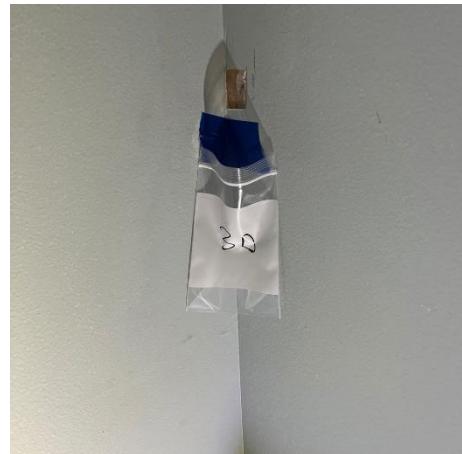
3D, Wall System, Left Front Bedroom

Client ID Lab ID	Lab Description	Lab Attributes	NON-ASBESTOS COMPONENTS			<b>ASBESTOS %</b>
			Fibrous	Non-Fibrous		
3D 3741904	Joint Compound W/ Blue Paint	Homogeneous Gray Non-Fibrous Bound		2% 20% 78%	Mica Paint Binder	<b>Chrysotile 2%</b>
Layer B 3741904	Tape	Homogeneous Gray Fibrous Loosely Bound	100%	Cellulose		<b>None Detected</b>
Layer C 3741904	Drywall	Heterogeneous Brown/gray Fibrous Bound	55%	Cellulose	45% Binder	<b>None Detected</b>
3E 3741905	Joint Compound W/ Dark-Blue Paint	Homogeneous Gray Non-Fibrous Bound		2% 25% 71%	Mica Paint Binder	<b>Chrysotile 2%</b>
Layer B 3741905	Tape	Homogeneous Brown Fibrous Loosely Bound	100%	Cellulose		<b>None Detected</b>
Layer C 3741905	Drywall	Heterogeneous Brown/gray Fibrous Bound	55%	Cellulose	45% Binder	<b>None Detected</b>
4A 3741906	Texture W/ White Paint	Homogeneous Light-gray Non-Fibrous Bound		2% 20% 78%	Mica Paint Binder	<b>Chrysotile 2%</b>

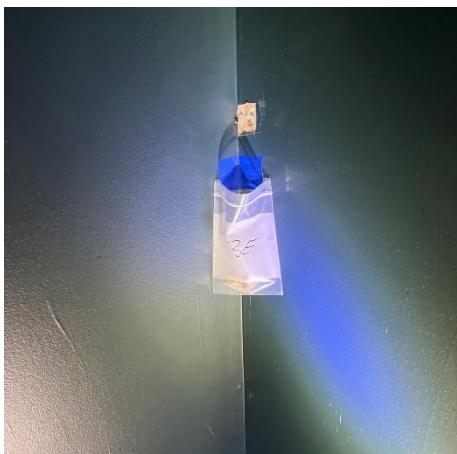
3E, Wall System, Left Back Bedroom

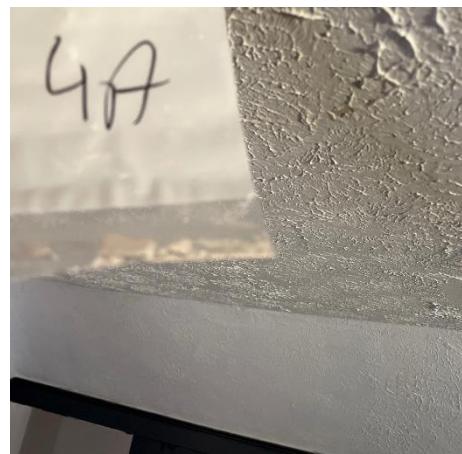
4A, Ceiling Texture, Kitchen

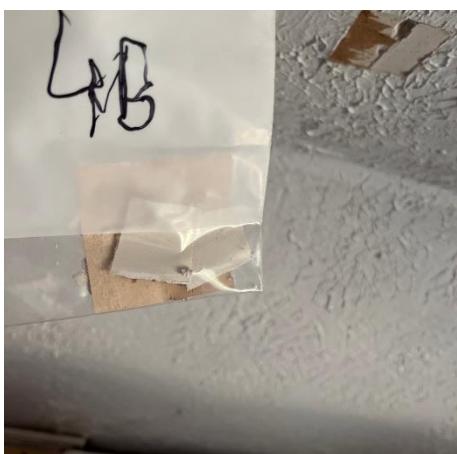
4B, Ceiling Texture, Kitchen

Client ID Lab ID	Lab Description	Lab Attributes	NON-ASBESTOS COMPONENTS			<b>ASBESTOS %</b>
			Fibrous	Non-Fibrous		
<b>4B</b> Layer A 3741907	Texture WI White Paint	Homogeneous		2%	Mica	<b>Chrysotile 2%</b>
		Gray		25%	Paint	
		Non-Fibrous		71%	Binder	
		Bound				
 Layer B 3741907	Tape	Homogeneous	100%	Cellulose		<b>None Detected</b>
		Beige				
		Fibrous				
		Loosely Bound				
 Layer C 3741907	Joint Compound	Homogeneous		2%	Mica	<b>Chrysotile 2%</b>
		Gray		98%	Binder	
		Non-Fibrous				
		Bound				
 Layer D 3741907	Drywall	Heterogeneous	70%	Cellulose	30%	<b>None Detected</b>
		Brown/gray				
		Fibrous				
		Bound				
 <b>4C</b> 3741908	Texture	Homogeneous		2%	Mica	<b>Chrysotile 2%</b>
		Gray		98%	Binder	
		Non-Fibrous				
		Bound

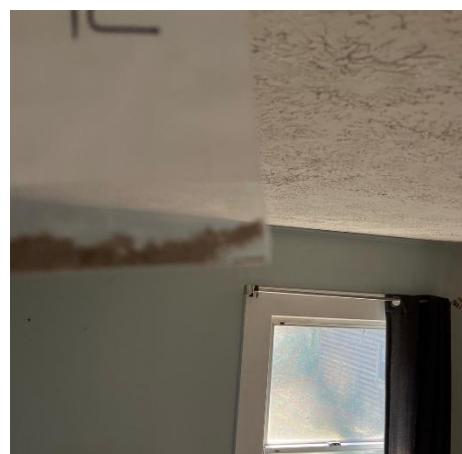
4C, Ceiling Texture, Left Front Bedroom

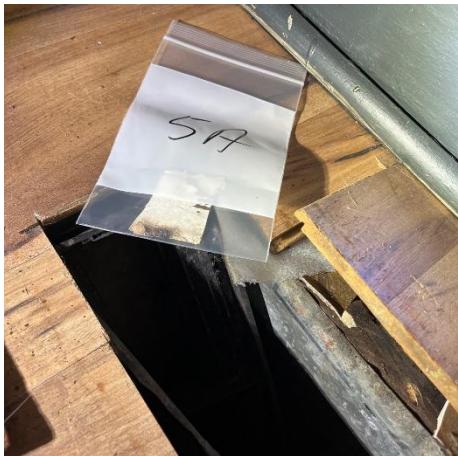
5A, Resilient Floor Covering, Kitchen

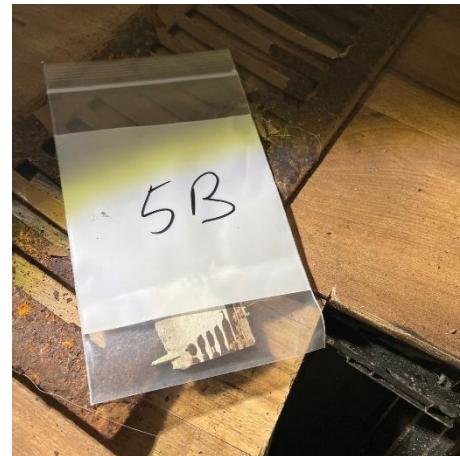
5B, Resilient Floor Covering, Kitchen

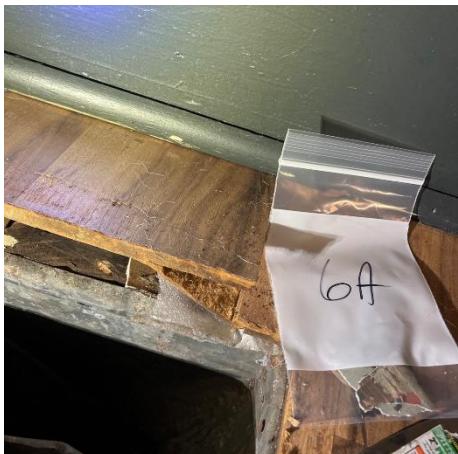
6A, Floor Tile, Kitchen

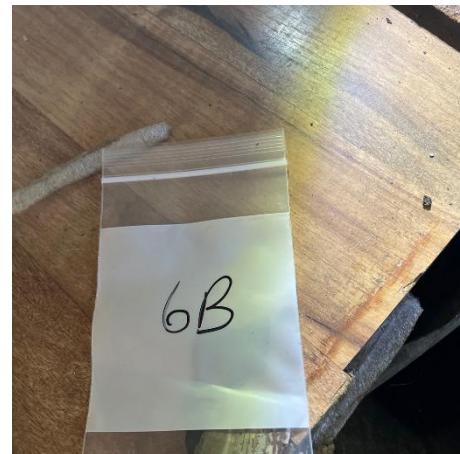
6B	Floor Tile	White 2nd Layer	Kitchen	40% Chrysotile
7A	Floor Tile	Black	Hallway	5% Chrysotile
7B	Floor Tile	Black	Hallway	5% Chrysotile
8A	Window Glazing	Grey	Kitchen	None Detected
8B	Window Glazing	Grey	Kitchen	None Detected
9A	Shingle	Black	Roof	None Detected
9B	Shingle	Black	Roof	None Detected

6B, Floor Tile, Kitchen

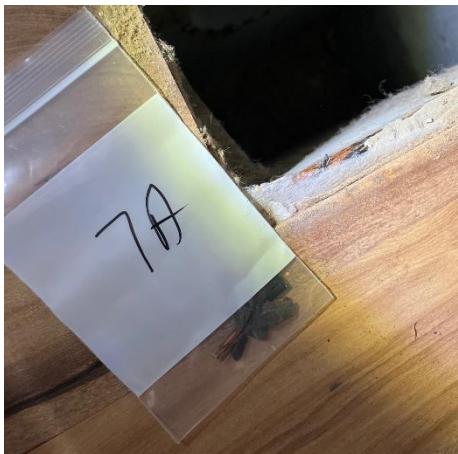
7A, Floor Tile, Hallway

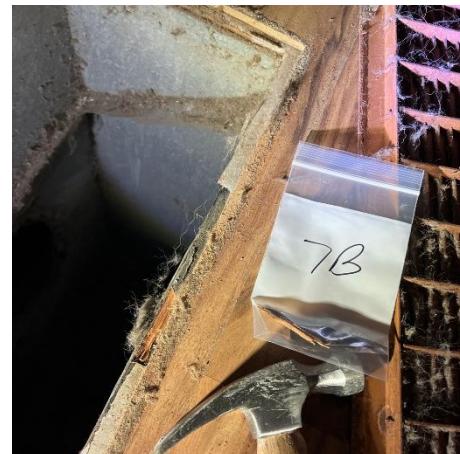
7B, Floor Tile, Hallway

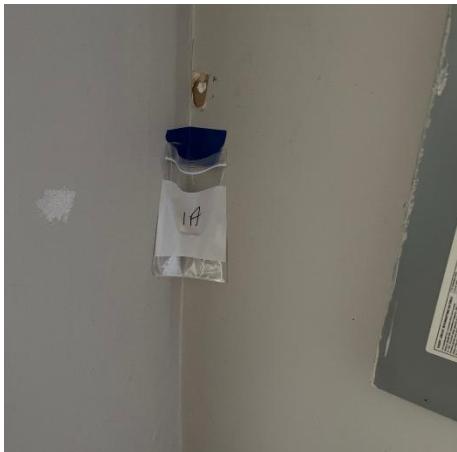
1A, Wall System, Living Room

Client ID Lab ID	Lab Description	Lab Attributes	NON-ASBESTOS COMPONENTS			<b>ASBESTOS %</b>	
			Fibrous	Non-Fibrous			
<b>1A</b> Layer A 3743231	Joint Compound W/ Light-Gray Paint	Homogeneous Gray Non-Fibrous Bound		10%	Paint	<b>Chrysotile 2%</b>	
				86%	Binder		
				2%	Mica		
<b>Layer B</b> 3743231	Tape	Homogeneous Gray Fibrous Loosely Bound	100%	Cellulose		<b>None Detected</b>	
<b>Layer C</b> 3743231	Drywall	Heterogeneous Brown/gray Fibrous Bound	15%	Cellulose	85%	Binder	<b>None Detected</b>
<b>1B</b> Layer A 3743232	Joint Compound W/ Light-Gray Multi- Layered Paint	Homogeneous Gray Non-Fibrous Bound		2%	Mica	<b>Chrysotile 2%</b>	
				20%	Paint		
				76%	Binder		
<b>Layer B</b> 3743232	Tape	Homogeneous Gray Fibrous Loosely Bound	100%	Cellulose		<b>None Detected</b>	
<b>Layer C</b> 3743232	Drywall	Heterogeneous Brown/gray Fibrous Bound	15%	Cellulose	85%	Binder	<b>None Detected</b>

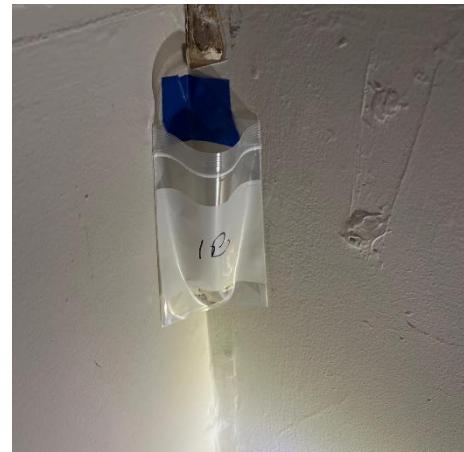
1B, Wall System, Left Back Bedroom

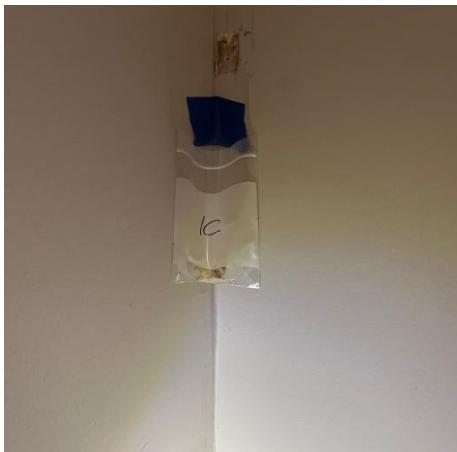
1C, Wall System, Dining Room

Client ID Lab ID	Lab Description	Lab Attributes	NON-ASBESTOS COMPONENTS			<b>ASBESTOS %</b>
			Fibrous	Non-Fibrous		
<b>1C</b> 3743233	Joint Compound W/ Layer A	Homogeneous Gray	2%	Mica	<b>Chrysotile 2%</b>	
	Layered Paint	Non-Fibrous Bound	20%	Paint		
			78%	Binder		
<b>Layer B</b> 3743233	Tape	Homogeneous Gray Fibrous Loosely Bound	100%	Cellulose		<b>None Detected</b>
<b>Layer C</b> 3743233	Drywall	Heterogeneous Brown/gray Fibrous Bound	15%	Cellulose	85%	Binder
						<b>None Detected</b>
<b>1D</b> 3743234	Joint Compound W/ Layer A	Homogeneous Gray	2%	Mica	<b>Chrysotile 2%</b>	
	Layered Paint	Non-Fibrous Bound	20%	Paint		
			78%	Binder		
<b>Layer B</b> 3743234	Tape	Homogeneous Gray Fibrous Loosely Bound	100%	Cellulose		<b>None Detected</b>
<b>Layer C</b> 3743234	Drywall	Heterogeneous Brown/gray Fibrous Bound	15%	Cellulose	85%	Binder
						<b>None Detected</b>

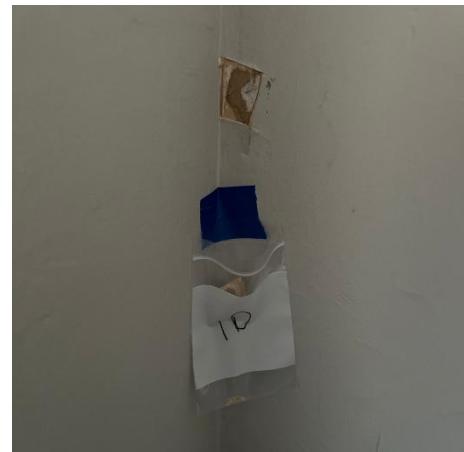
1D, Wall System, Kitchen

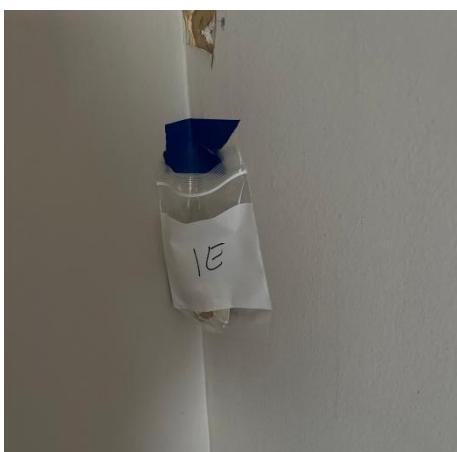
1E, Wall System, Right Front Room

Client ID Lab ID	Lab Description	Lab Attributes	NON-ASBESTOS COMPONENTS		ASBESTOS %		
			Fibrous	Non-Fibrous			
<b>1E</b> 3743235	Joint Compound W/ Layer A	Homogeneous Gray	20%	Paint	<b>Chrysotile 2%</b>		
	Light-Gray Multi- 3743235	Layered Paint Bound	2%	Mica			
			78%	Binder			
<b>Layer B</b> 3743235	Tape	Homogeneous Gray Fibrous Loosely Bound	100%	Cellulose	<b>None Detected</b>		
<b>Layer C</b> 3743235	Drywall	Heterogeneous Brown/gray Fibrous Bound	15%	Cellulose	85%	Binder	
						<b>None Detected</b>	
<b>2A</b> 3743236	Texture W/ Layer A	White Paint	Homogeneous Gray	2%	Mica	<b>Chrysotile 2%</b>	
			Non-Fibrous Bound	10%	Paint		
				88%	Binder		
<b>Layer B</b> 3743236	Foam W/ Paint, Yellow	White Adhesive	Homogeneous Gray Non-Fibrous Loosely Bound	2% 8% 10% 80%	Mastic Binder Paint Foam	<b>None Detected</b>	
<b>2B</b> 3743237	Texture W/ Paint	White	Homogeneous Gray	2%	Mica	<b>Chrysotile 2%</b>	
			Non-Fibrous Bound	10%	Paint

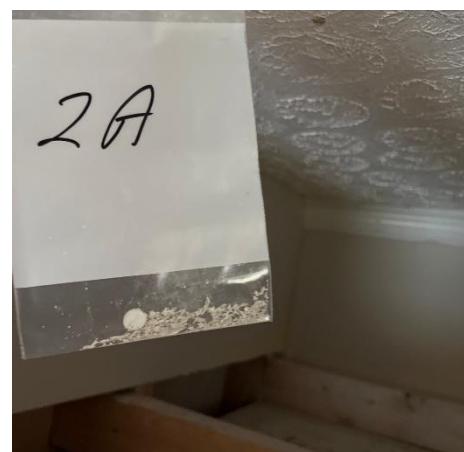
2A, Ceiling Texture, Living Room

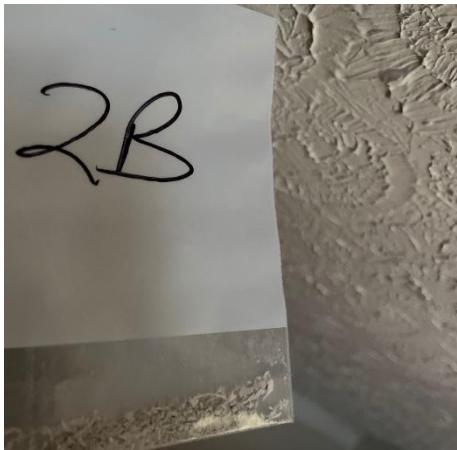
2B, Ceiling Texture, Living Room

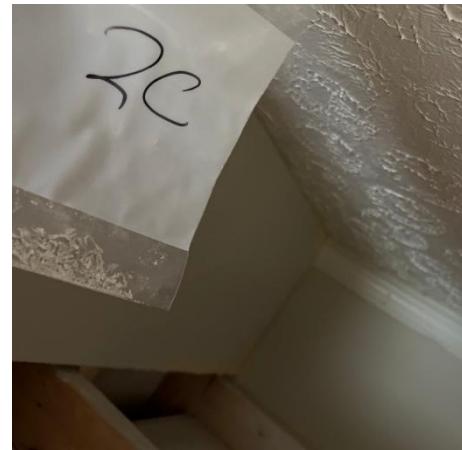
2C, Ceiling Texture, Living Room

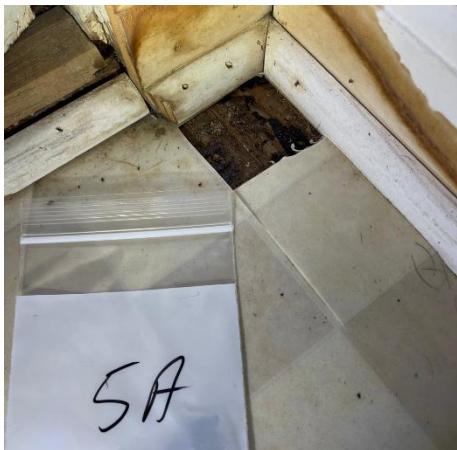
5A, Tar Paper, Bathroom

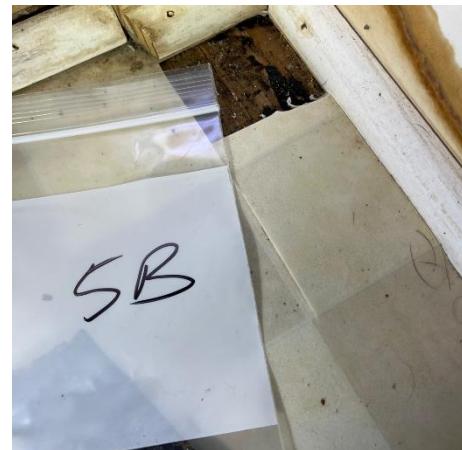
5B, Tar Paper, Bathroom

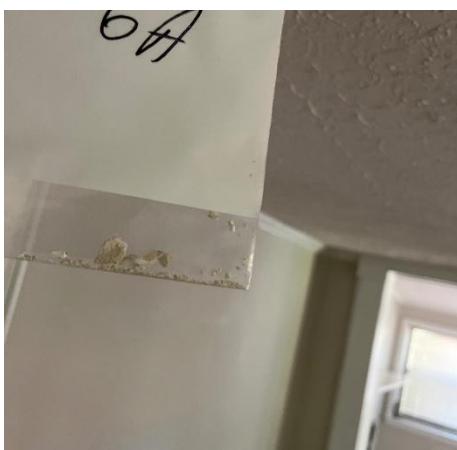
6A, Ceiling Texture, Kitchen

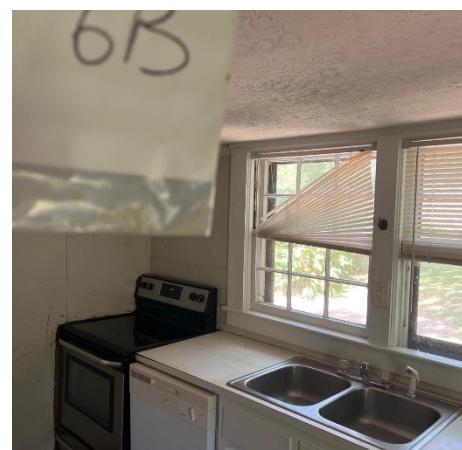
6B, Ceiling Texture, Kitchen

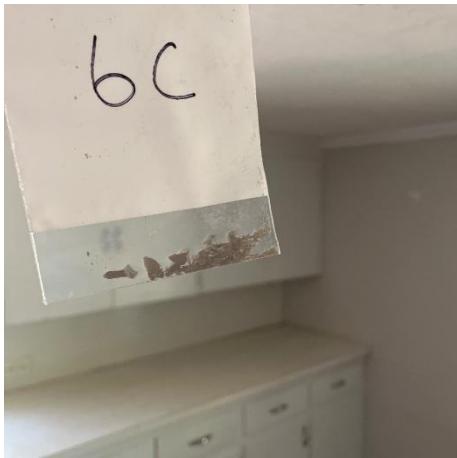
6C, Ceiling Texture, Kitchen
