Road Safety Audit

US 129 / SR 15 ALT / JEFFERSON ROAD
FROM LAVENDER ROAD TO SOUTH HOMEWOOD DRIVE
ATHENS-CLARKE COUNTY | GEORGIA

Prepared for the Georgia Department of Transportation

December 2016

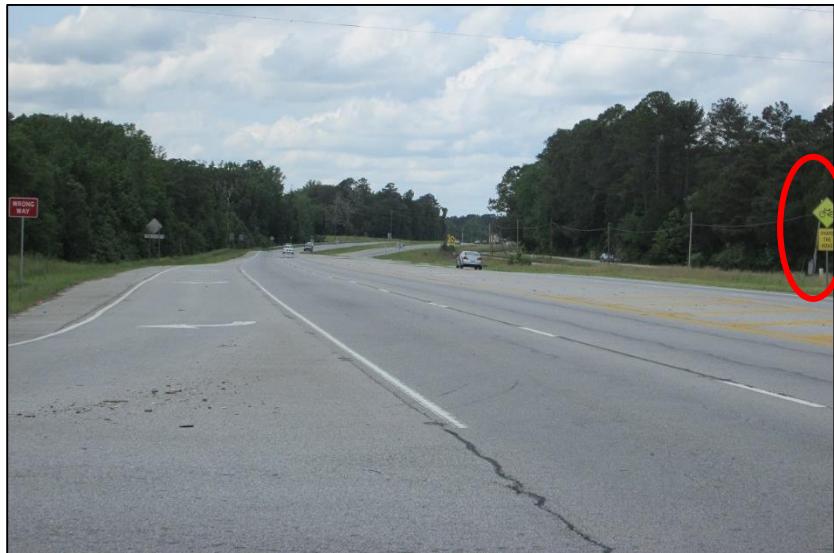
FIGURE 10. VIEW OF NORTH END OF CORRIDOR, LOOKING NORTH FROM LAVENDER ROAD. NOTE THE "SHARE THE ROAD" SIGN FOR BICYCLES IN THE NORTHBOUND LANES.

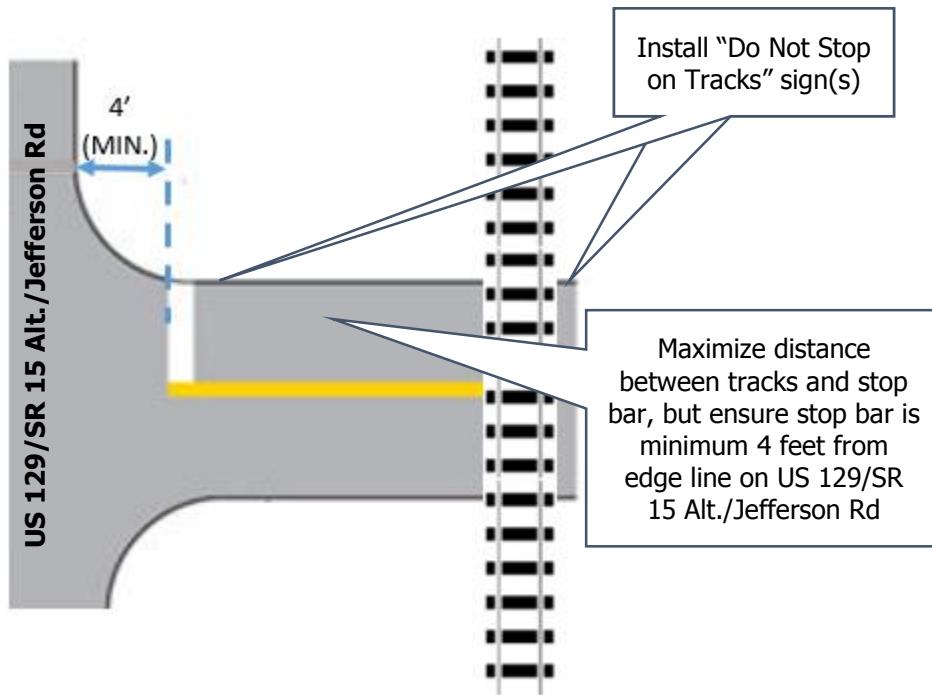
FIGURE 20. DIAGRAM ILLUSTRATING RECOMMENDED PLACEMENT OF STOP BAR RELATIVE TO RAILROAD CROSSINGS.

As described in Section 8B.28 of the Manual on Uniform Traffic Control Devices (MUTCD), stop lines on paved at-grade crossings equipped with active control devices such as signals or gates should be installed a minimum of eight feet in advance of the gate, but no closer than 15 feet in advance of the nearest rail. A stop line at an intersection with a cross-street must be no closer than four feet from the edge line of the intersecting road.

The MUTCD also provides guidance on the placement of "Do Not Stop On Tracks" (B8-8) signs (Section 8B.09). These should be installed whenever the potential for vehicles stopping on the tracks at a grade crossing is significant. Placement of these signs should be determined as part of an engineering study, and should be provided on the right side of the roadway on either the near or far side of the grade crossing, depending upon visibility to approaching drivers.

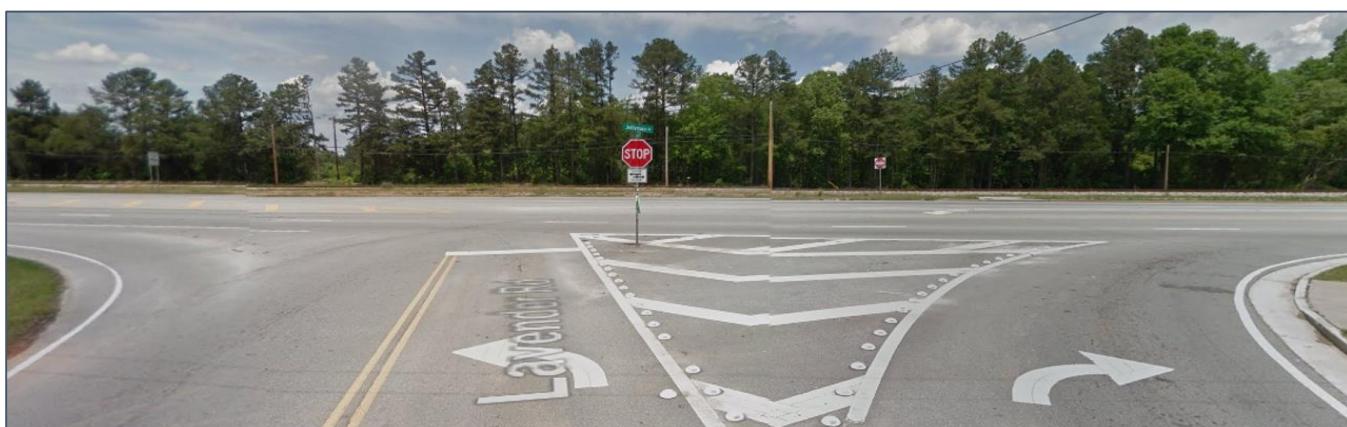
FIGURE 23. PAINTED ISLAND AT LAVENDER ROAD.

SAFETY BENEFIT	LEVEL OF EFFORT	TIME FRAME	COST
1. Remove or reposition the "Do Not Enter" sign on the east side of the intersection.	Moderate	Low	Short Term	Low
2. Adjust the angle of the yield sign in the southwest quadrant to make it more visible to motorists turning right from Lavender Road onto the study corridor.	Moderate	Low	Short Term	Low
3. Replace the street sign for Lavender Road with a reflective street sign.	High	Low	Short Term	Low
4. Consider replacing the painted island with a concrete one to channelize turns and improve visibility of the side street.	Moderate	Moderate	Intermediate	Moderate
5. Consider redesigning the intersection to remove the skew angle. Identify and carry out implementation steps as appropriate.	High	High	Long Term	High

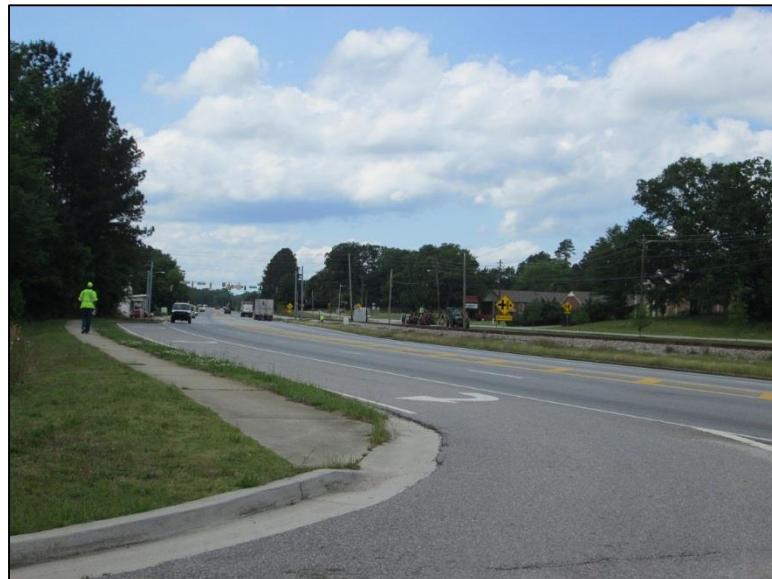
FIGURE 31. VIEW LOOKING NORTHBOUND FROM STOP BAR ON FIREFIGHTER COURT.

SAFETY BENEFIT	LEVEL OF EFFORT	TIME FRAME	COST
1. Relocate the stop bar across Firefighter Court closer to the intersection.	High	Low	Short Term	Low
2. Adjust the angle of the "Do Not Enter" sign to face the proper direction.	Moderate	Low	Short Term	Low

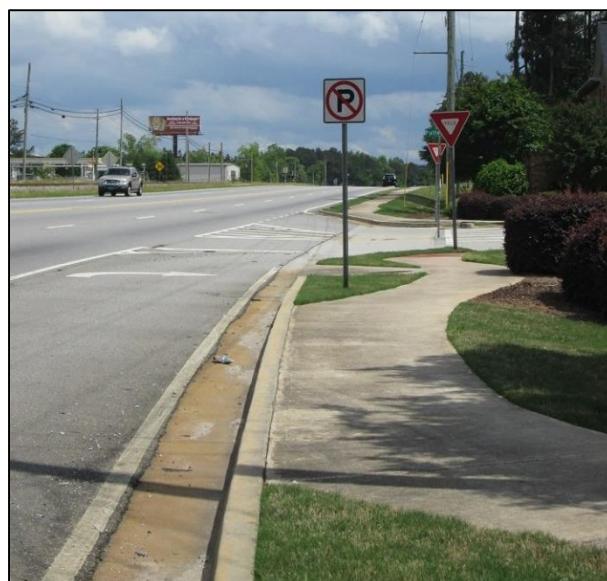
FIGURE 42. (RIGHT) VIEW LOOKING SOUTHBBOUND ACROSS PUTTERS DRIVE.

SAFETY BENEFIT	LEVEL OF EFFORT	TIME FRAME	COST
1. Investigate sight distance issues at the intersection and consider converting Putters Drive to right-in/right-out. Implement if determined to be feasible.	High	Moderate	Intermediate	Moderate
2. Replace the "Watch for Stopped Trucks" sign so that it is more visible and reflective.	Moderate	Low	Short Term	Low

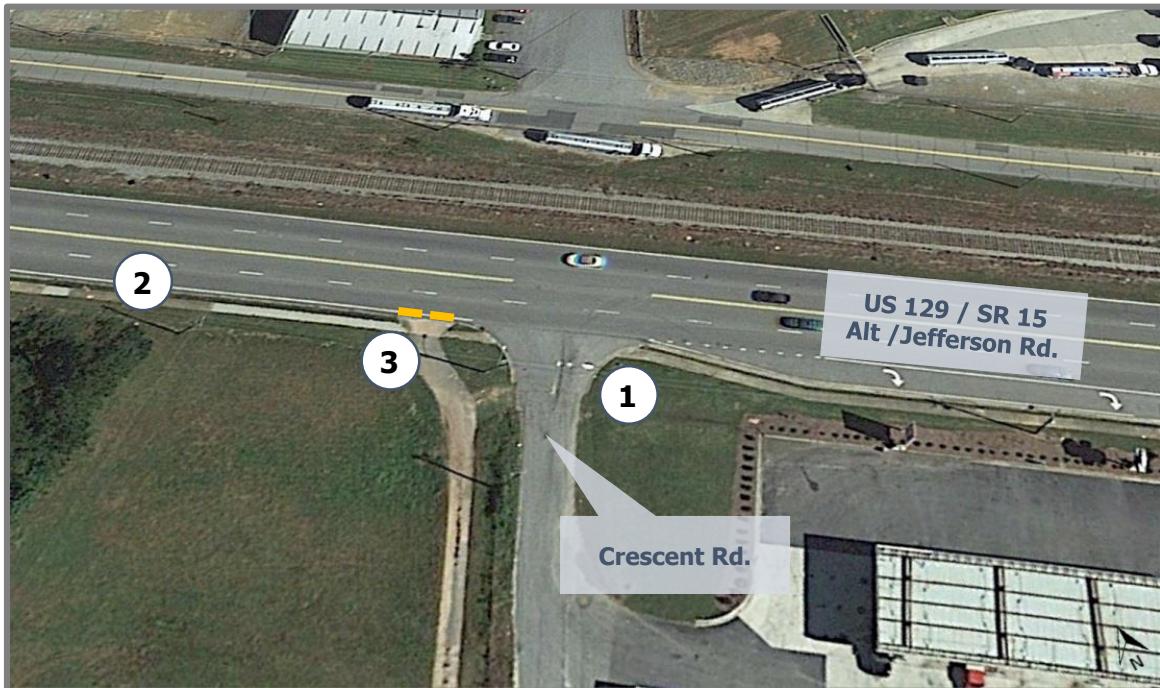
FIGURE 46. DIAGRAM OF RECOMMENDATIONS FOR CRESCENT ROAD.

1. There is **no street sign** for Crescent Road.
2. **Debris and sediment** was observed in the roadway, indicating **poor drainage at the intersection**.
3. On US 129/SR 15 Alt/Jefferson Road just north of Crescent Road, there is a **driveway that is too close to the intersection**.

SAFETY BENEFIT	LEVEL OF EFFORT	TIME FRAME	COST
1. Install a post-mounted street name sign for Crescent Road at the intersection.	High	Low	Short Term	Low
2. Investigate and repair the drainage issues at the intersection if warranted.	Moderate	High	Intermediate	Moderate
3. Reconfigure or re-locate the driveway to have its access point on Crescent Road rather than on the study corridor.	High	Moderate	Intermediate	Moderate

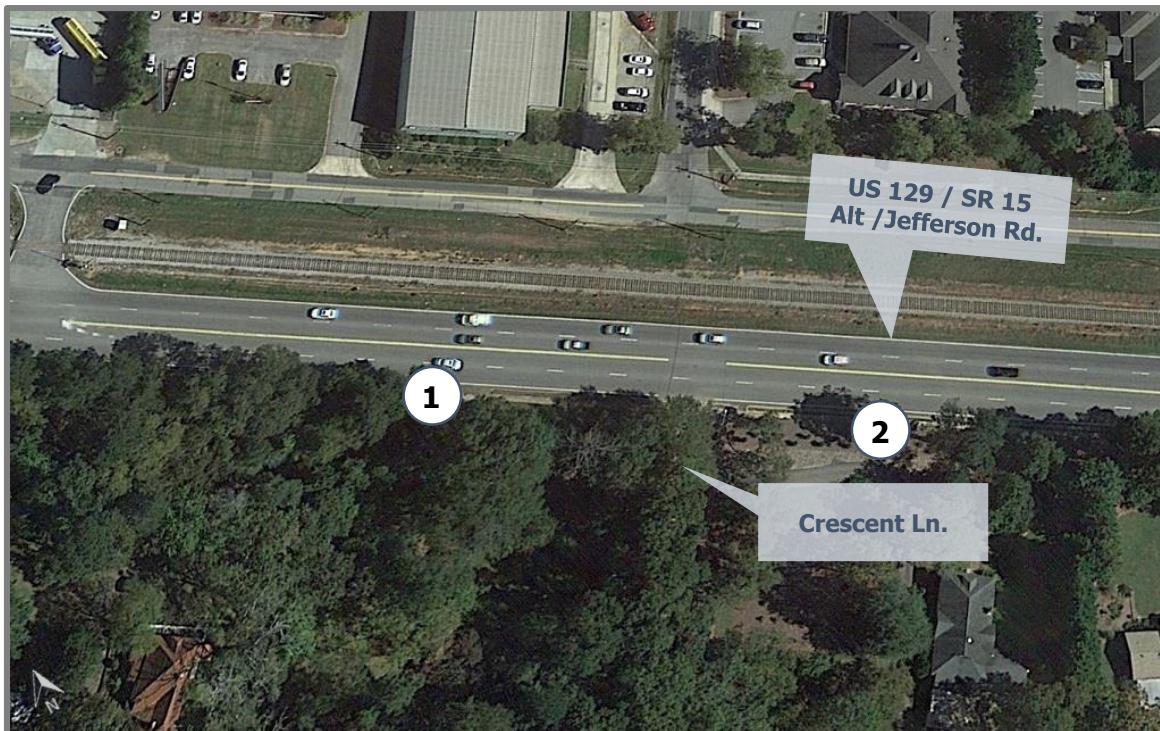
FIGURE 49. DIAGRAM OF RECOMMENDATIONS FOR AREA AROUND CRESCENT LANE.

1. Crescent Lane is a **private road**.
2. **Sediment** from the retaining wall at the south of the intersection was observed **on the sidewalk**.
3. Just south of Crescent Lane, a **speed limit sign blocks the "Intersection Ahead" sign** for Kathwood Drive from some angles.

SAFETY BENEFIT	LEVEL OF EFFORT	TIME FRAME	COST
1. Clear the sediment from the sidewalk and repair the retaining wall at the intersection.	Moderate	Low	Short Term	Low
2. Relocate speed limit and "Intersection Ahead" signs so they do not block one another.	Moderate	Low	Short Term	Low

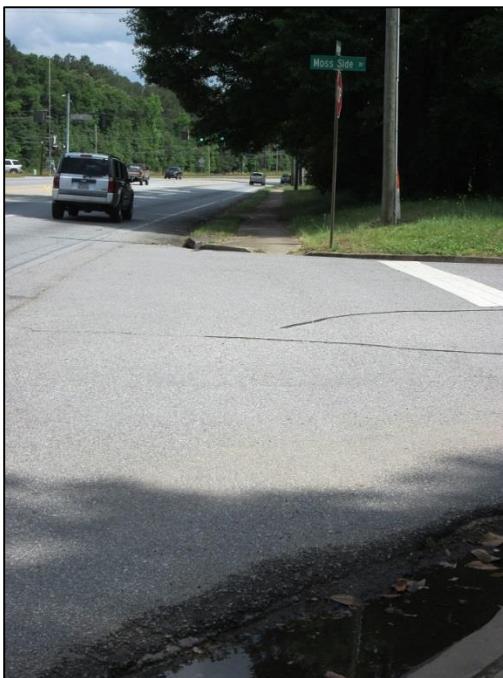
FIGURE 51. VIEW SOUTHBOUND ACROSS MOSS SIDE DRIVE.

SAFETY BENEFIT	LEVEL OF EFFORT	TIME FRAME	COST
1. Install an advanced warning "Intersection Ahead" sign for Moss Side Drive in both directions.	High	Low	Short Term	Low
2. Trim vegetation at the intersection to improve visibility south of the Moss Side Drive on the west side of US 129/SR 15 Alt/Jefferson Road.	High	Low	Short Term	Low
3. Investigate sight distance at the intersection and consider converting Moss Side Drive to right-in/right-out, directing northbound traffic to the signal at Trinity Place. Implement if determined to be feasible.	High	Moderate	Intermediate	Moderate

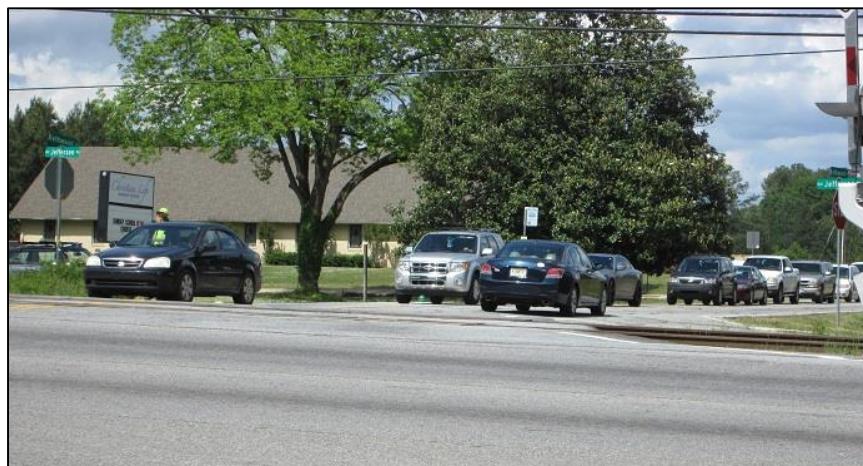
1. Kathwood Drive has **good connectivity** with several other roads in the vicinity and as such, experiences a decent volume of vehicular traffic.
2. The audit team observed a **substantial amount of traffic waiting at the signal** on Kathwood Drive during the field inspection (in the middle of the afternoon). After a full green cycle, the team counted more than 12 vehicles waiting at the signal on Kathwood Drive to access US 129/SR 15 Alt/Jefferson Road.
3. The **traffic signal heads** at the intersection appear to be **hanging too low** from the overhead wires.

FIGURE 54. VEHICLES WAITING AT THE TRAFFIC SIGNAL ON KATHWOOD DRIVE.

SAFETY BENEFIT	LEVEL OF EFFORT	TIME FRAME	COST
1. Investigate the height of the traffic signal heads and adjust if needed.	High	Low	Short Term	Low
2. Conduct a study to determine the feasibility of closing the intersection at Kathwood Drive and US 129/SR 15 Alt/Jefferson Road or converting Kathwood Drive to right-in/right-out. This would reduce the potential number of conflict points along the RSA corridor. Implement if determined to be feasible. <i>Note: One potential barrier to this recommendation is the substantial volume of traffic that already uses Kathwood Drive for access to US 129/SR 15 Alt/Jefferson Road. Traffic counts may need to be considered.</i>	Moderate	Low	Short Term	Low

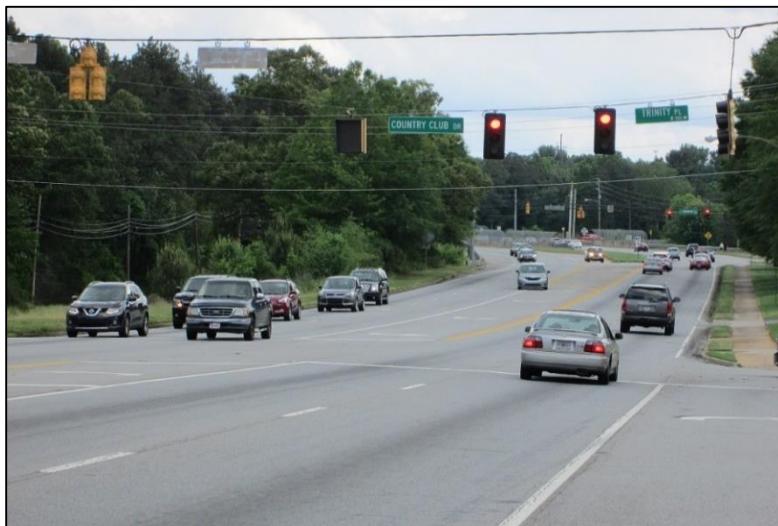
1. Traveling southbound and northbound, the **advanced “Intersection Ahead” and railroad crossing warning signs** for Trinity Place **do not indicate Country Club Drive** to the east of the study corridor.
2. The **reduced speed limit warning sign** for southbound traffic is **damaged** (about 1,000 feet north of Trinity Place).
3. The **sidewalks** on the west side of US 129/SR 15 Alt/Jefferson Road are **not aligned correctly** across Trinity Place, due to the right-turn only lane from the study corridor onto Trinity Place.

FIGURE 58. VIEW SOUTHBOUND ACROSS TRINITY PLACE/COUNTRY CLUB DRIVE.

SAFETY BENEFIT	LEVEL OF EFFORT	TIME FRAME	COST
1. Add a name plate for Country Club Drive to the advanced warning signs for Trinity Place north and south of the intersection.	Moderate	Low	Short Term	Low
2. Replace the reduced speed limit warning sign for southbound vehicles north of Trinity Place.	Moderate	Low	Short Term	Low
3. Realign the sidewalks at the west side of the intersection, across Trinity Place.	High	Moderate	Intermediate	Moderate
